MODEL A FORD WIRING

Keeping the Current Flowing

Distributed by:
 Model A Ford Club of America
 250 S. Cypress Street
 La Habra, California 90631

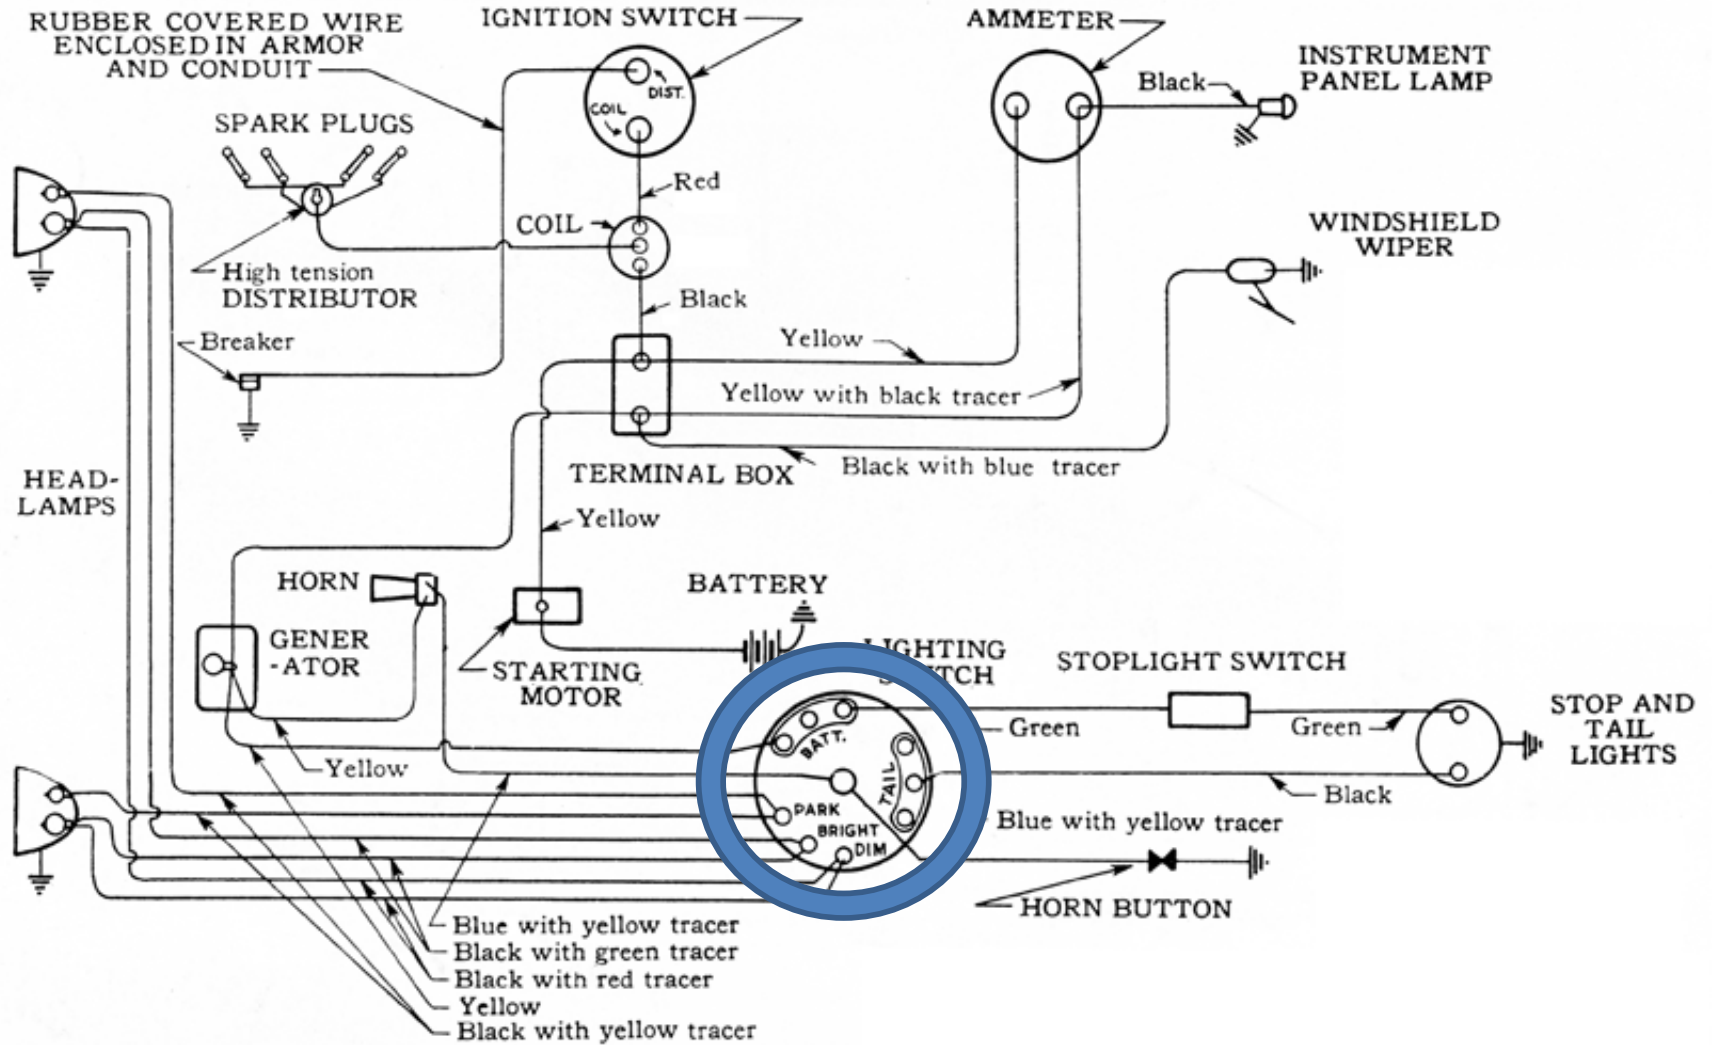
Model A Ford ENGINE WIRING 1928-1931

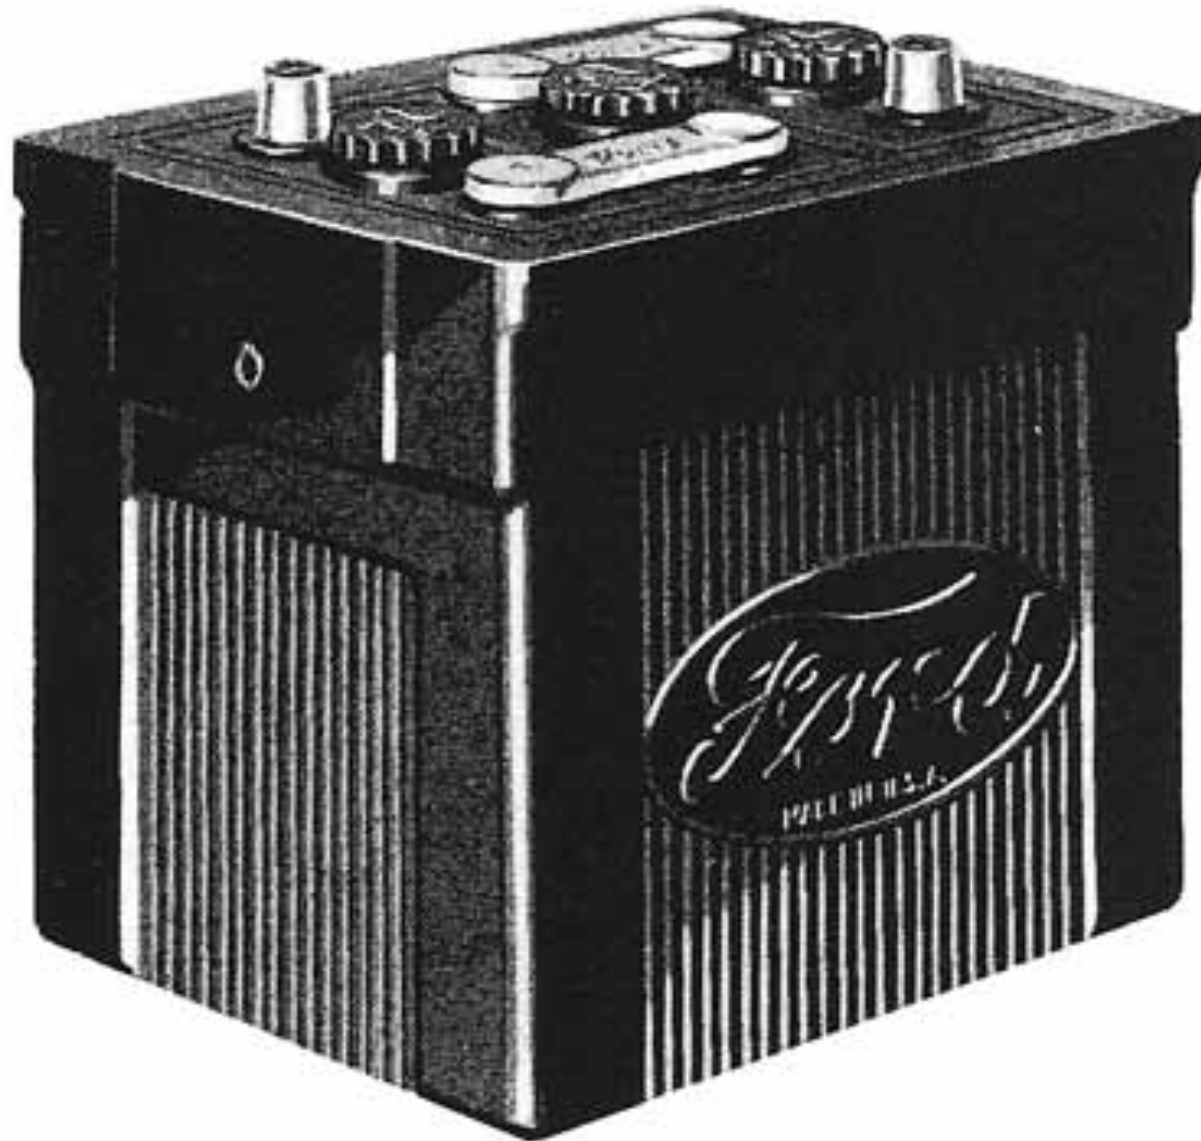
Battery

- Correct polarity – 6V ground is **Positive**
- Keep electrolyte levels correct – distilled water
- Caps in place
- Keep connections clean and tight
- Keep fully charged – trickle charges a good idea
- Do not over charge – 10 amps for average driving
- Keep securely mounted
- Connect ground strap last

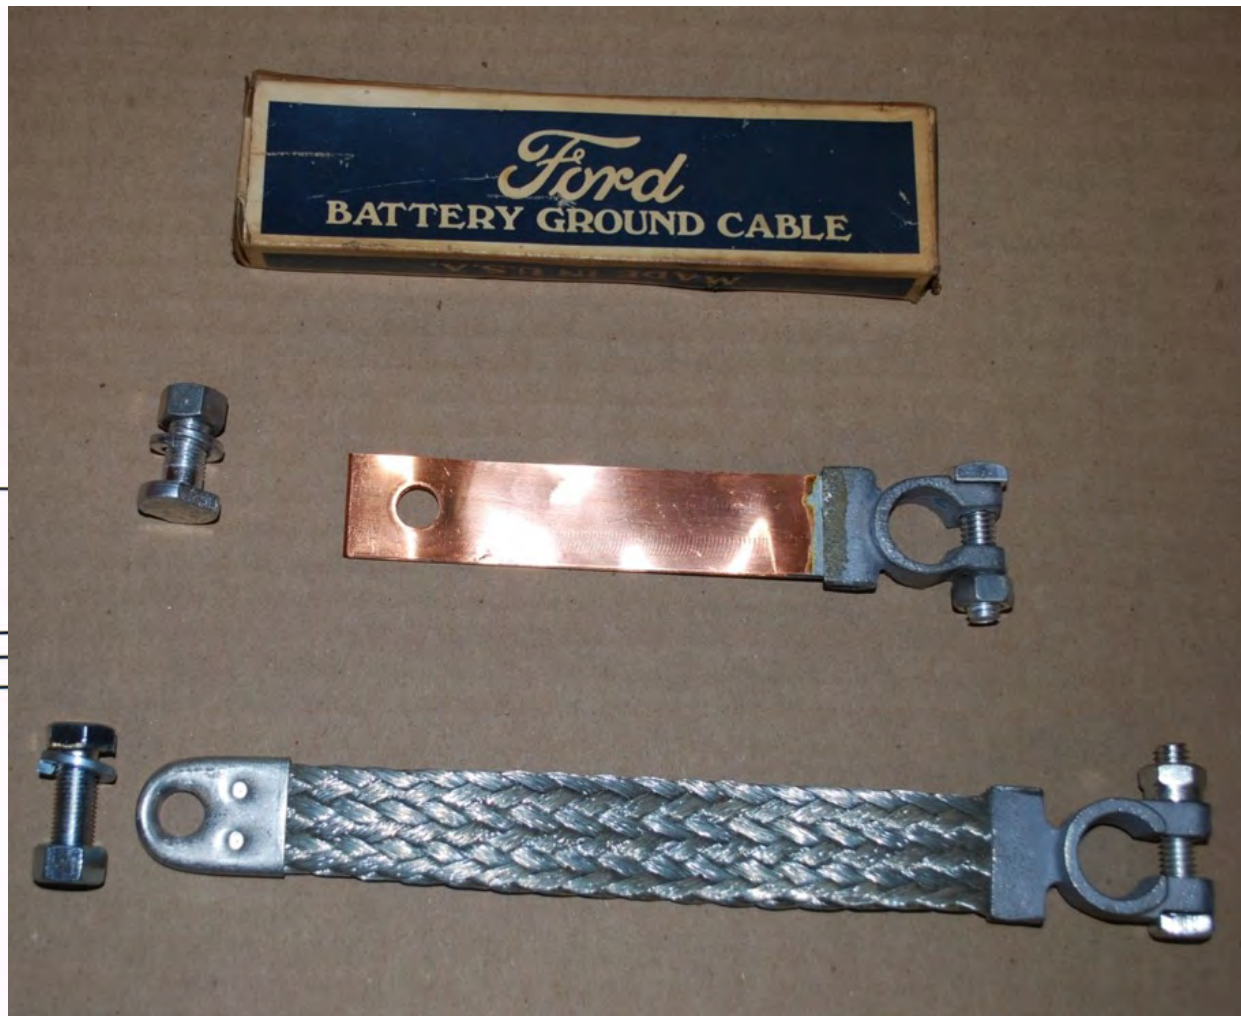
Battery Ground Cable

Service Bulletin - March 1930

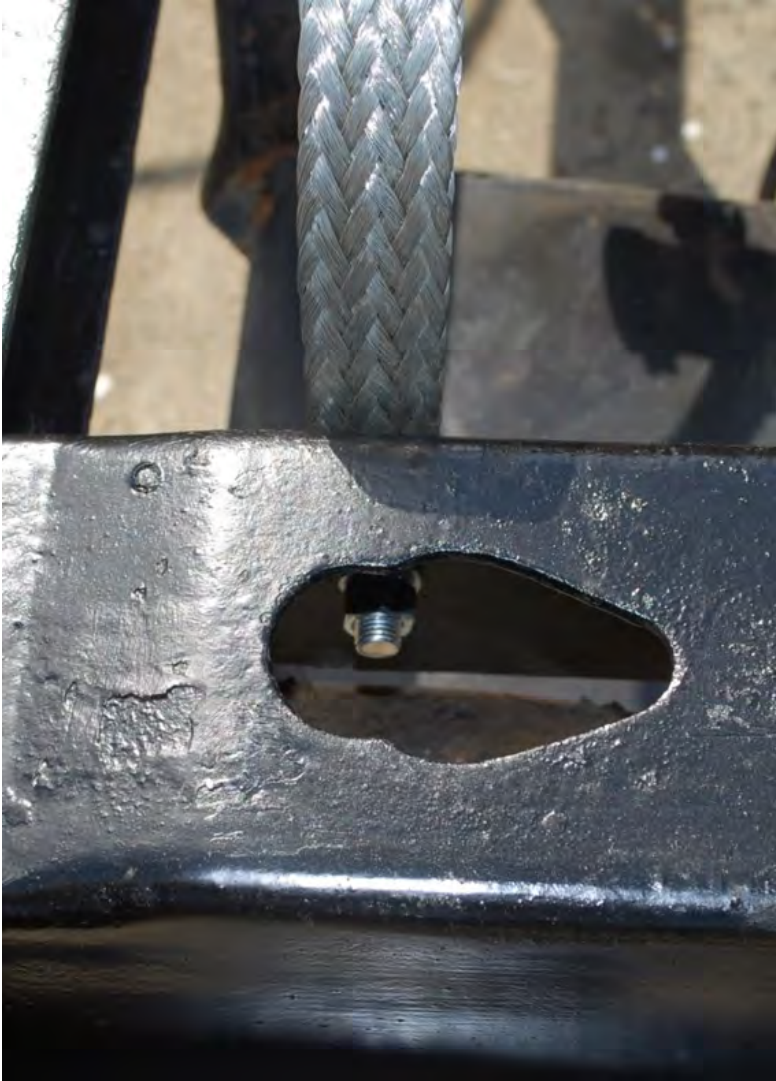
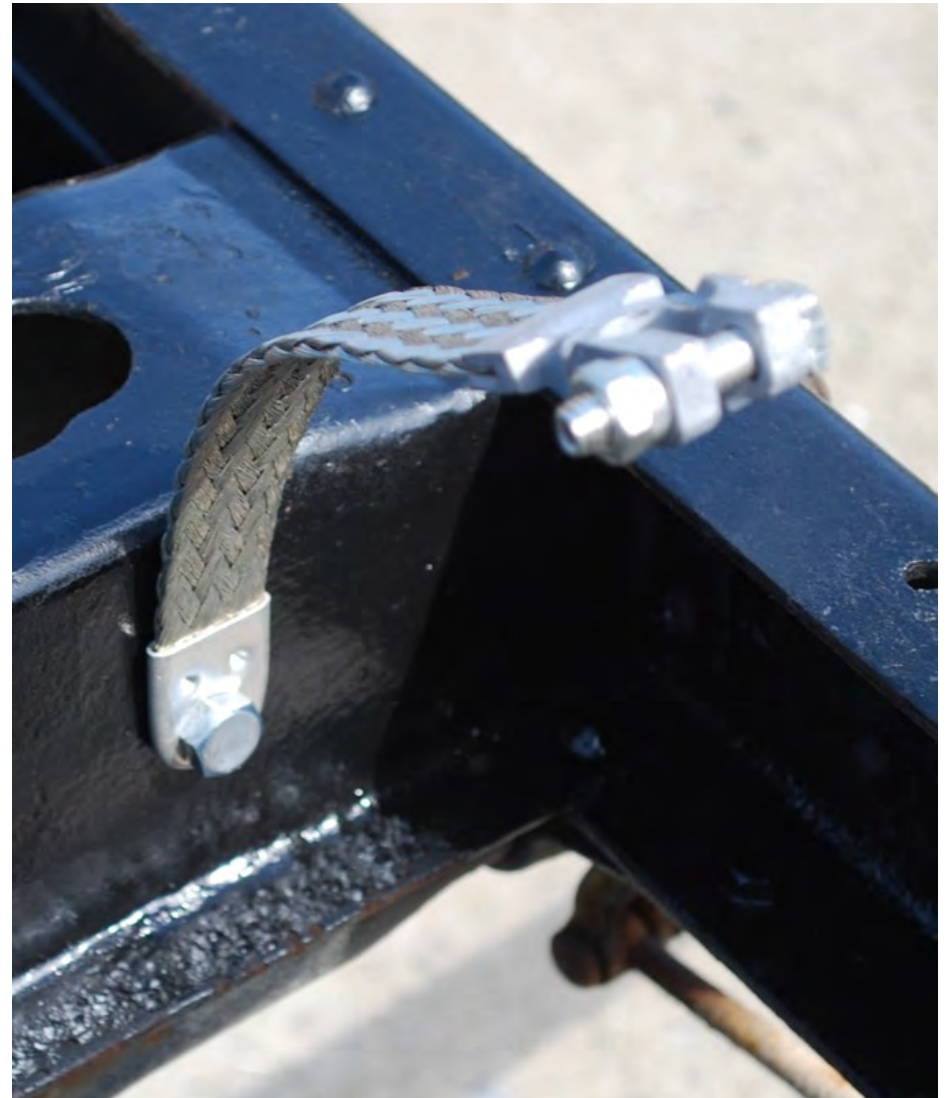
Fig. 798

Ground Cable Attached

Modern Cable #2
wire

Model A Cable #1
wire

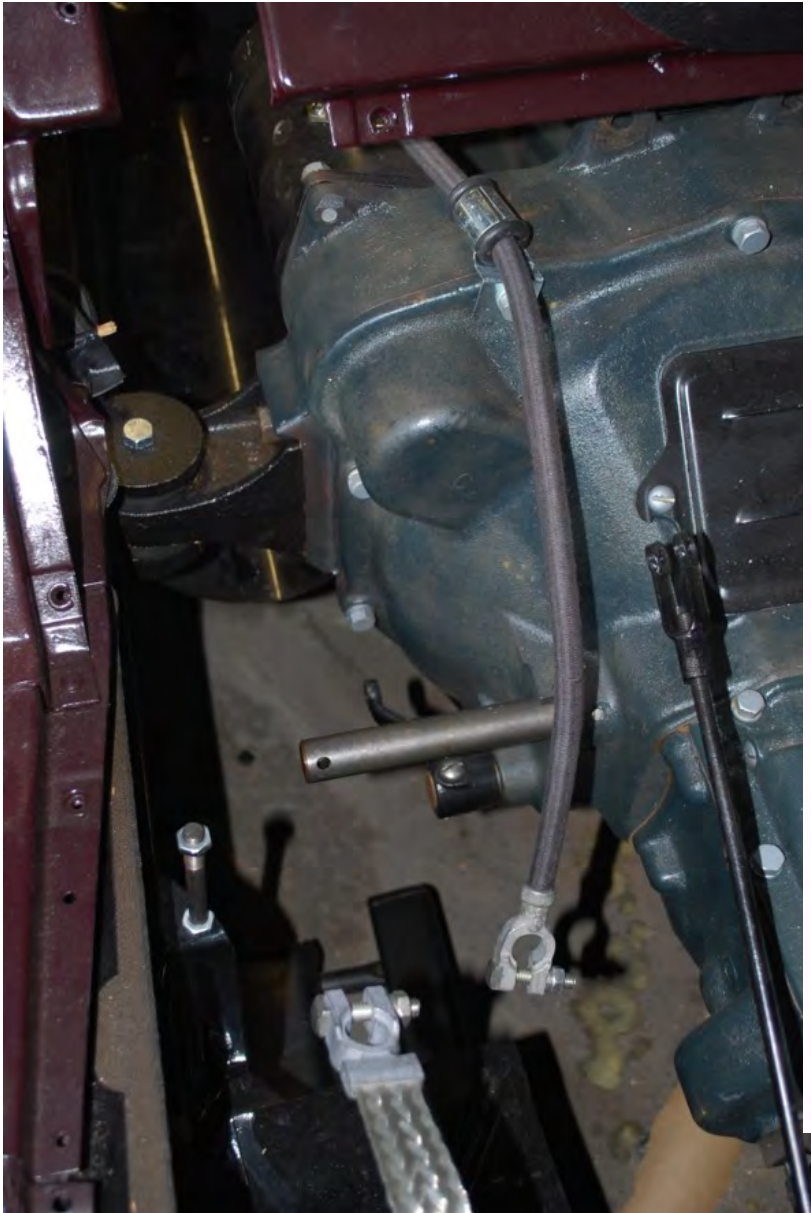
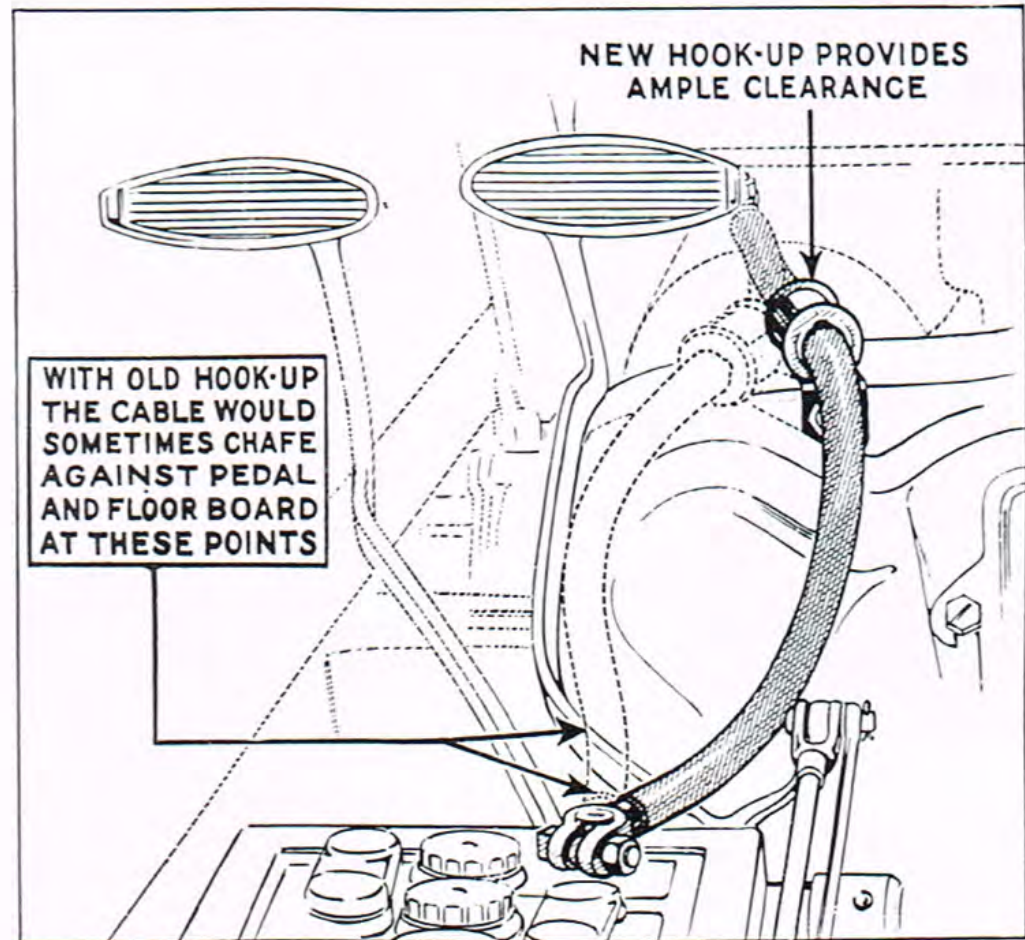
Fig. 797

Battery Cable Routing

Dotted Lines Show Location of Old Cable

Service Bulletin – November 1929

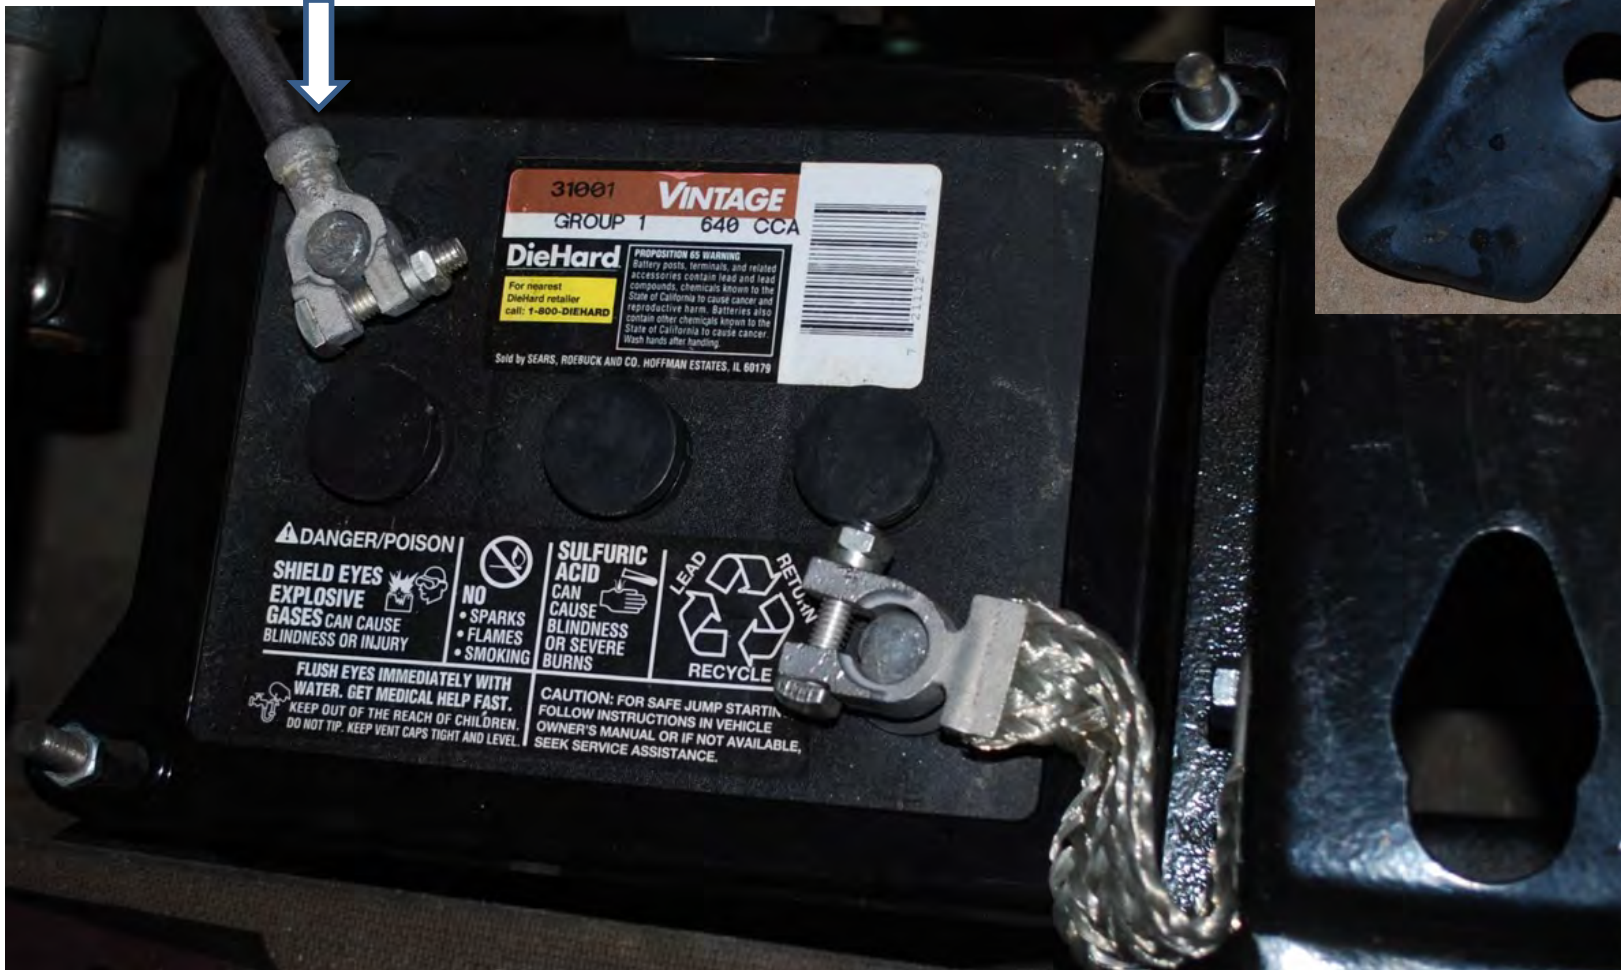
Battery Mounted

Use care to ensure no contact with battery hold down

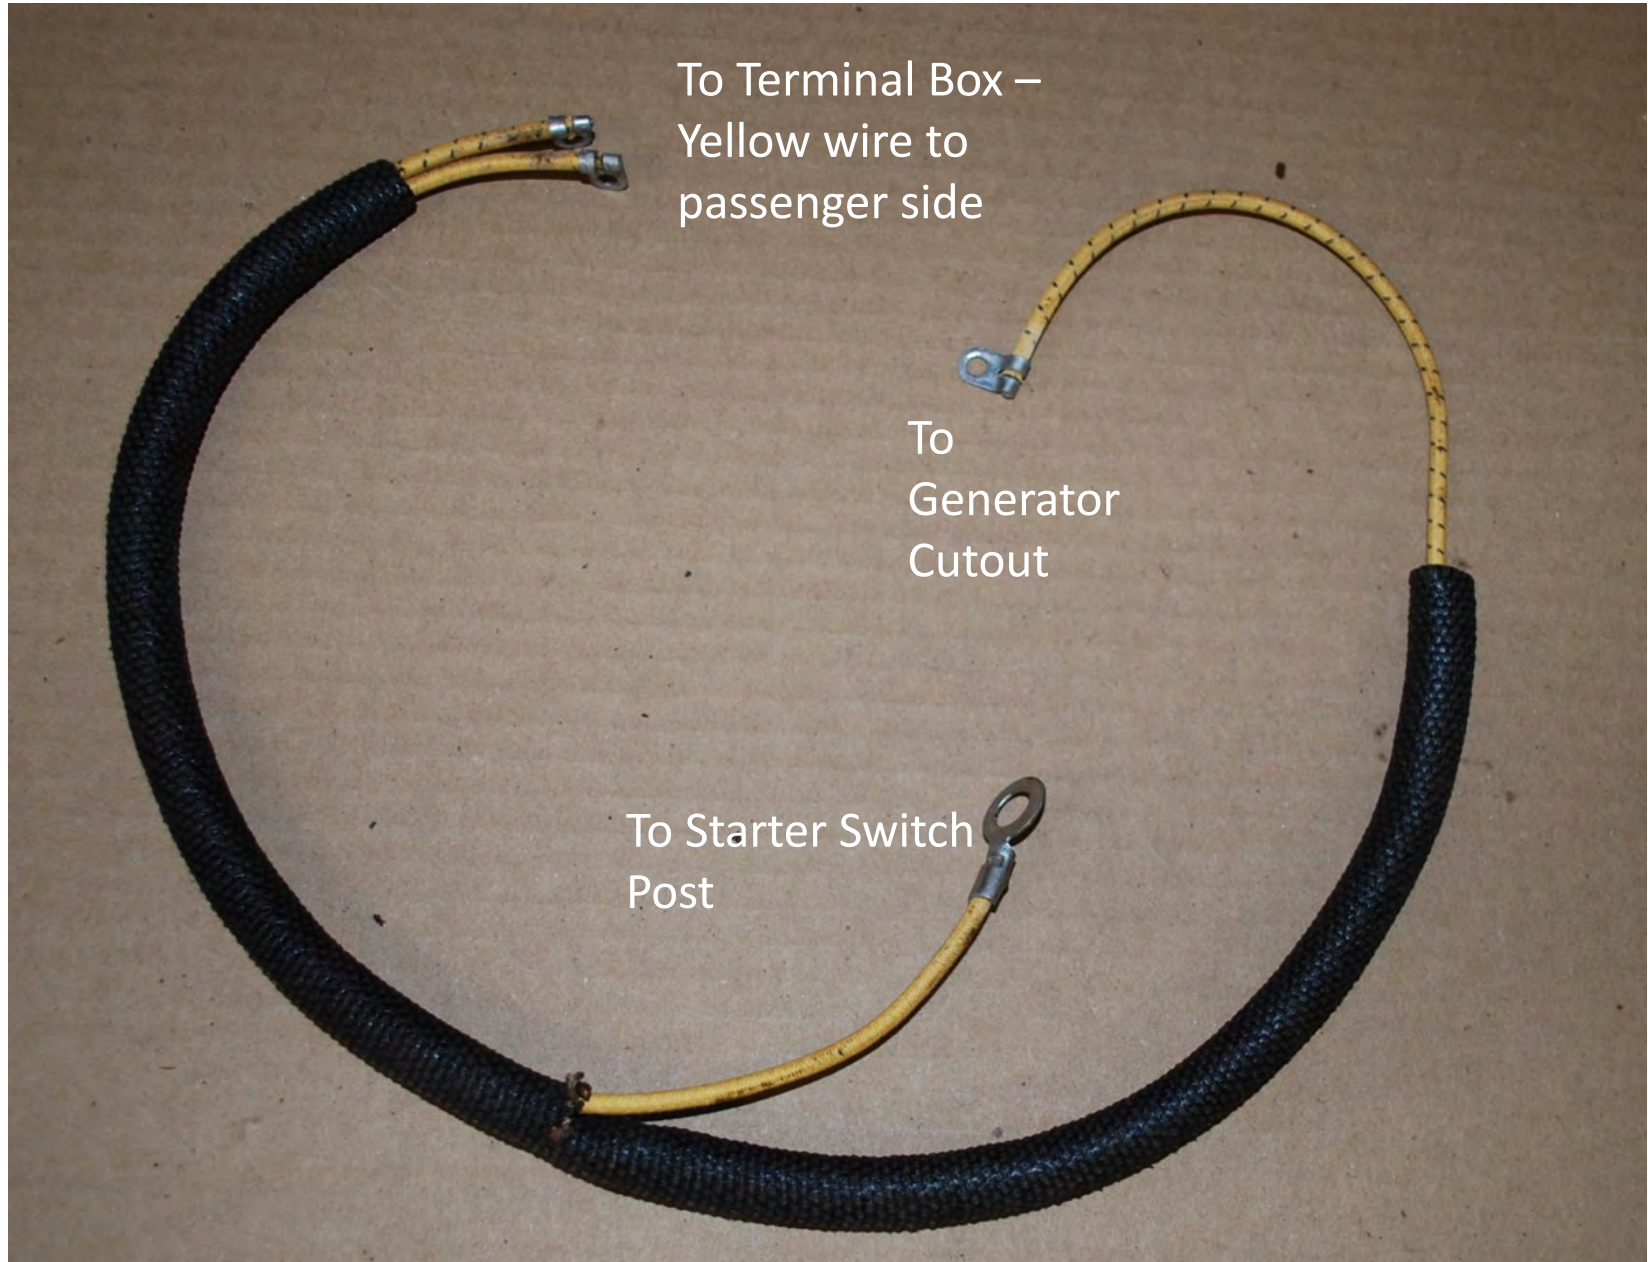
Cut Out to Terminal Box Wiring Harness

1928-1929 Models Used a Steel Conduit

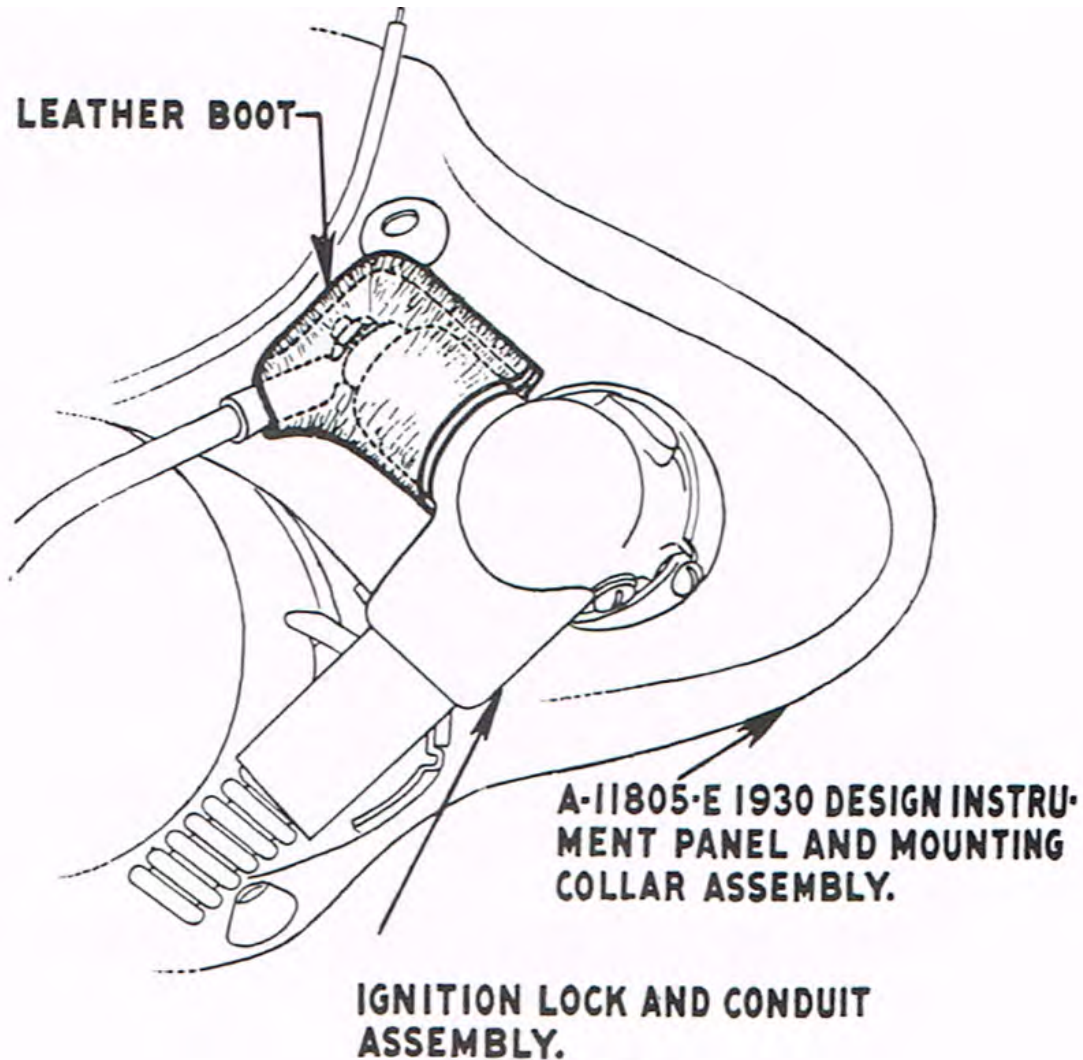
Fig. 921

Clearance is Minimal – Protect Connections

Service Bulletin
June 1930

For trucks, but
dash and gas tank
are the same

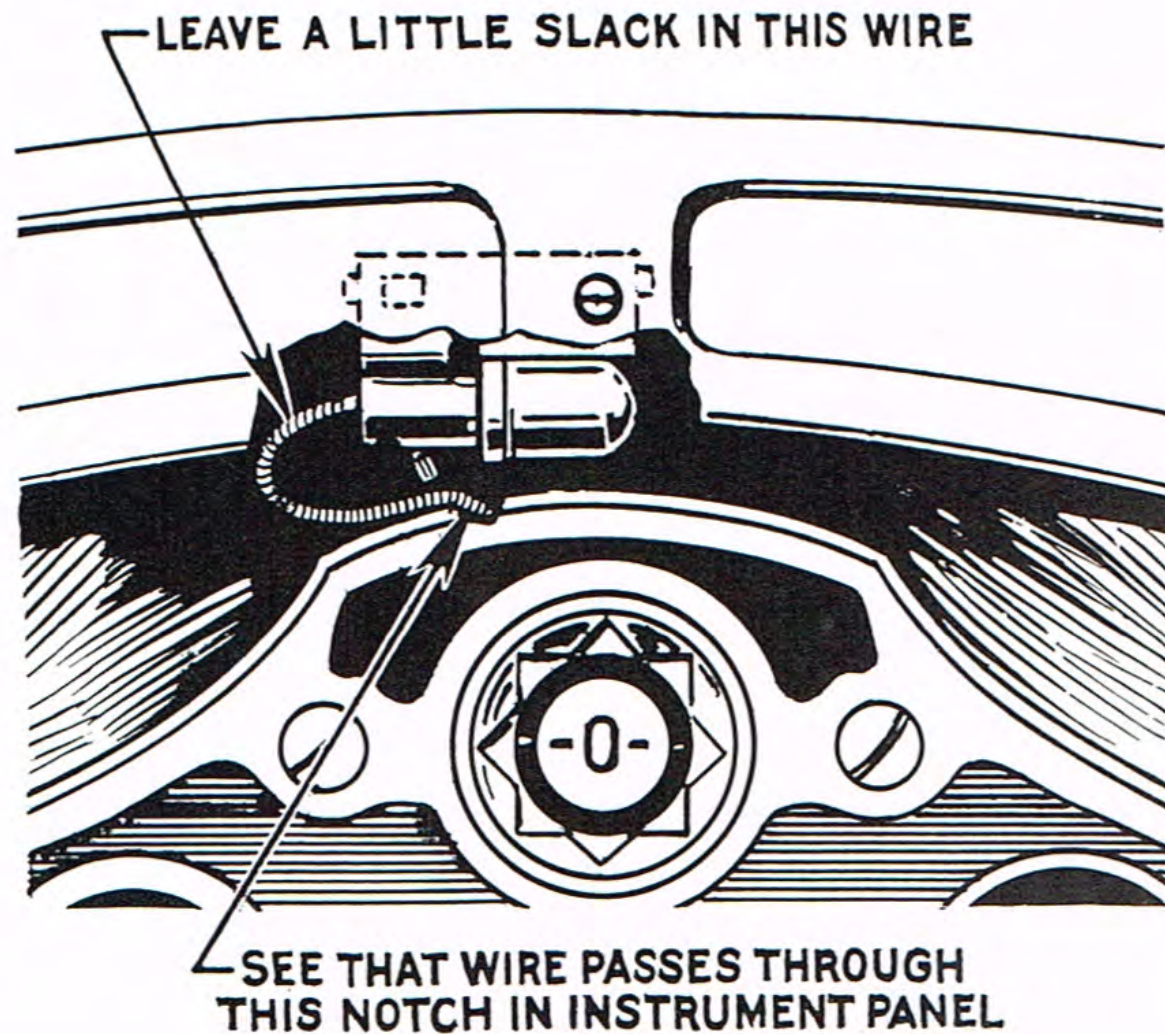
Fig. 919

Slack in Instrument Light

Service Bulletin
June 1930

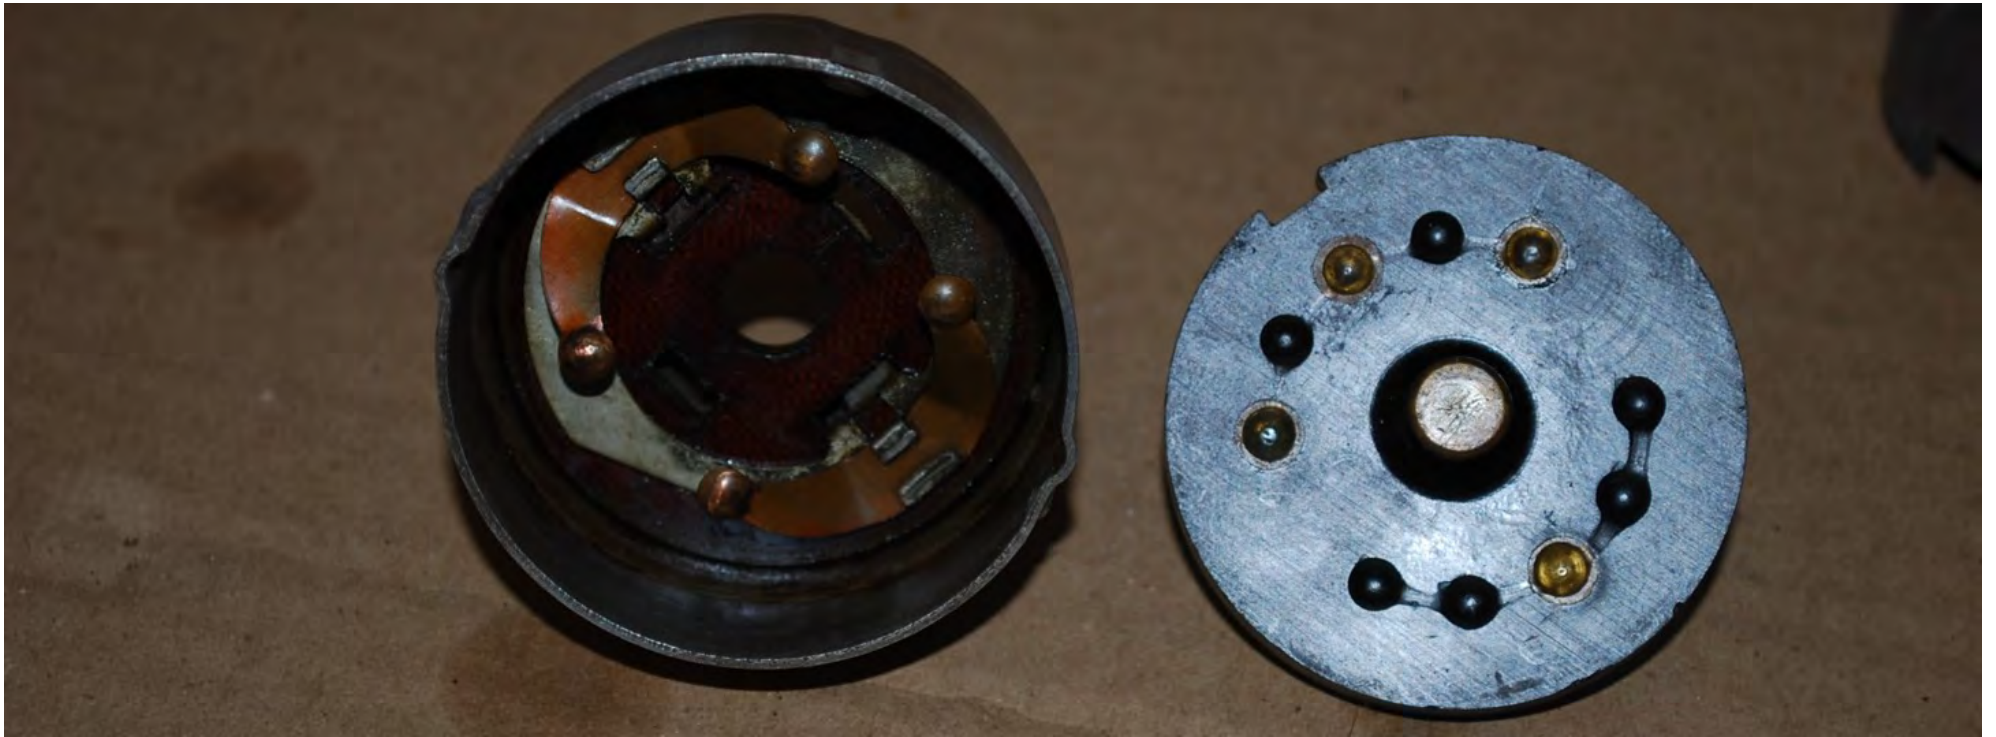
Light Switch Connections – Used After February 1928 with Ford “H” Headlights (Fluted Lens)

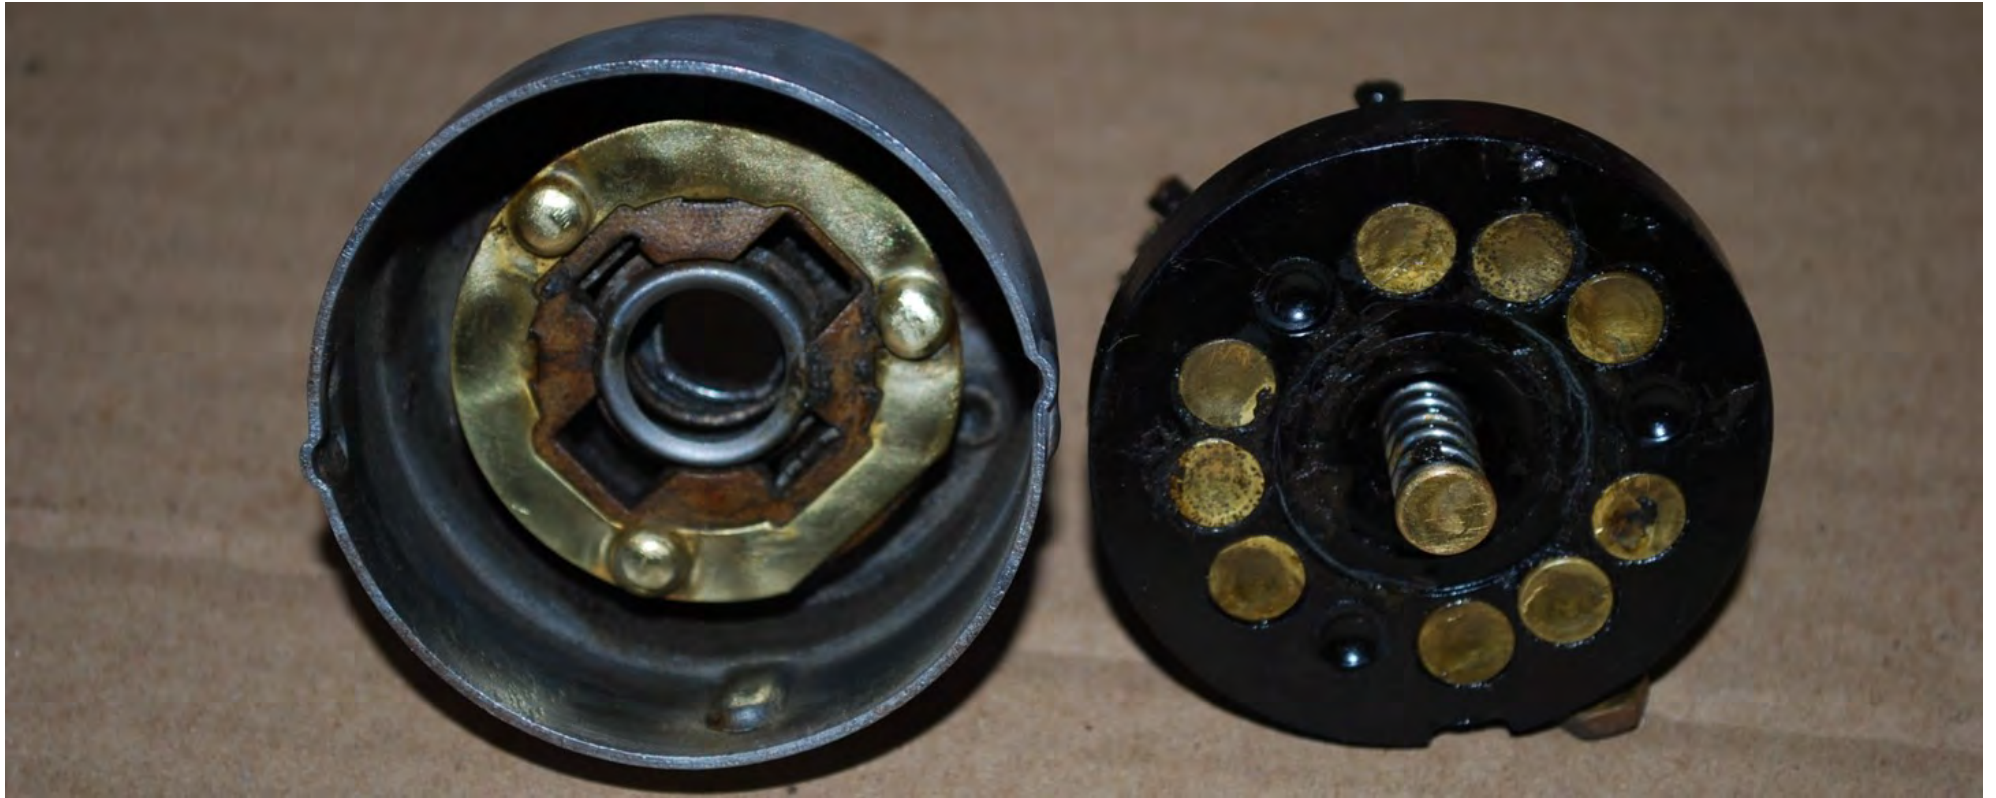
Light Switch Connections Used with Twolight headlamps

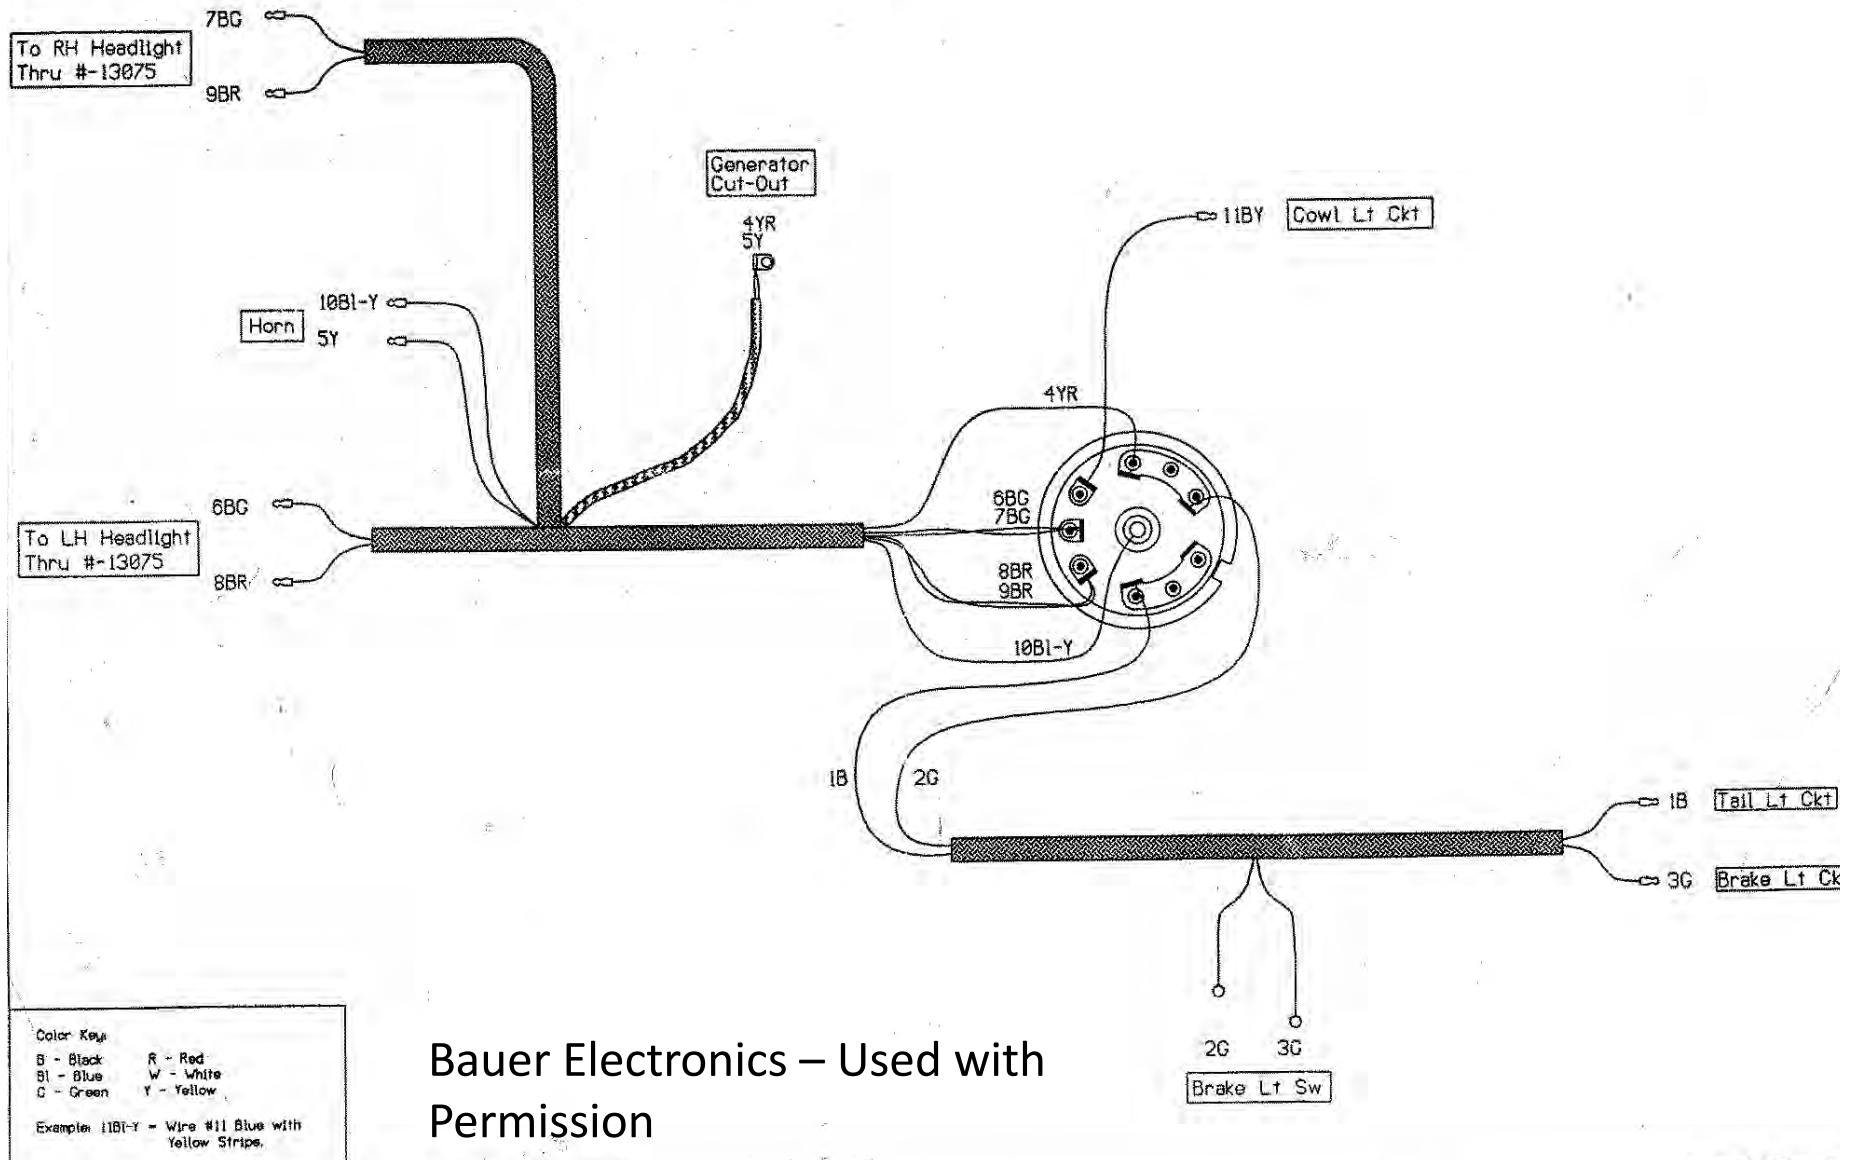
Wiring Harness w/ Cowl Lights

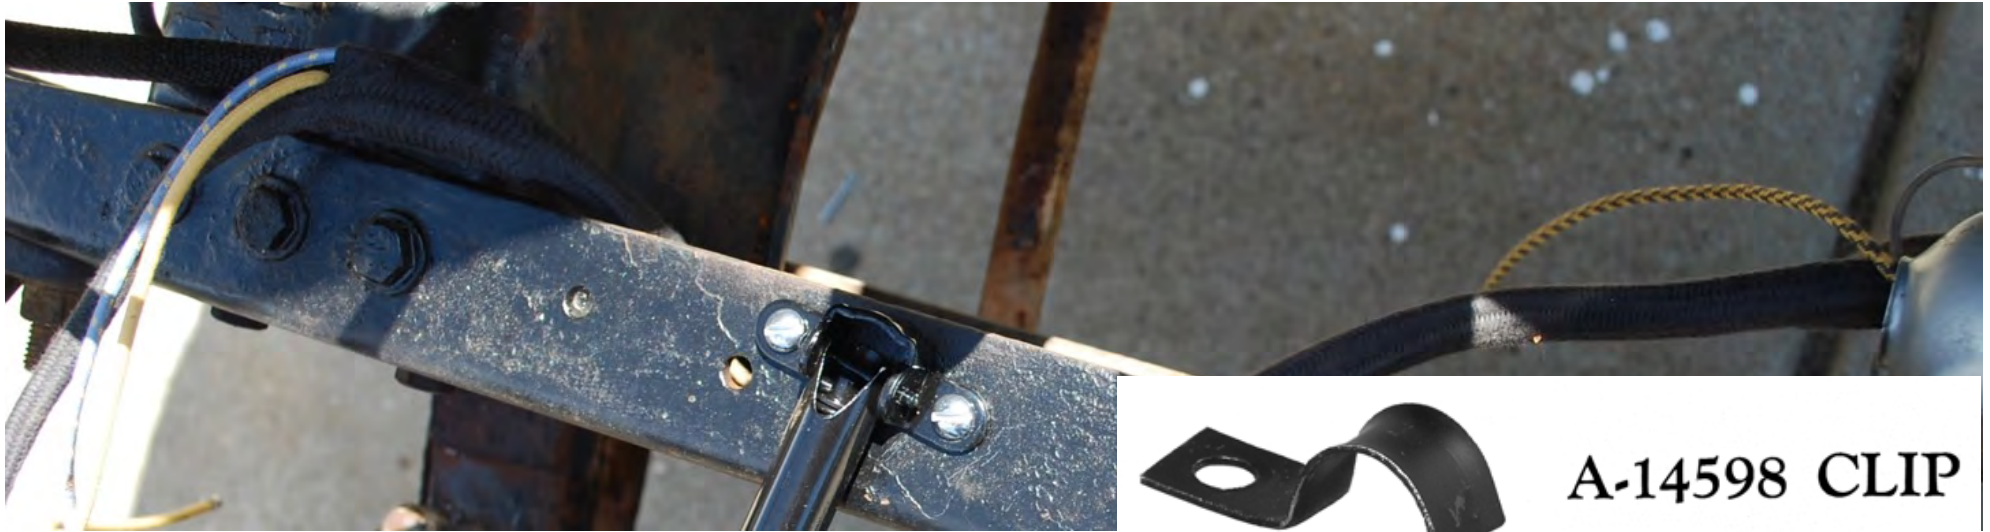
Wiring Clip Under Hood Latch

A-14598 CLIP
