MODEL A FORD WIRING

Keeping the Current Flowing

Distributed by:
 Model A Ford Club of America
 250 S. Cypress Street
 La Habra, California 90631

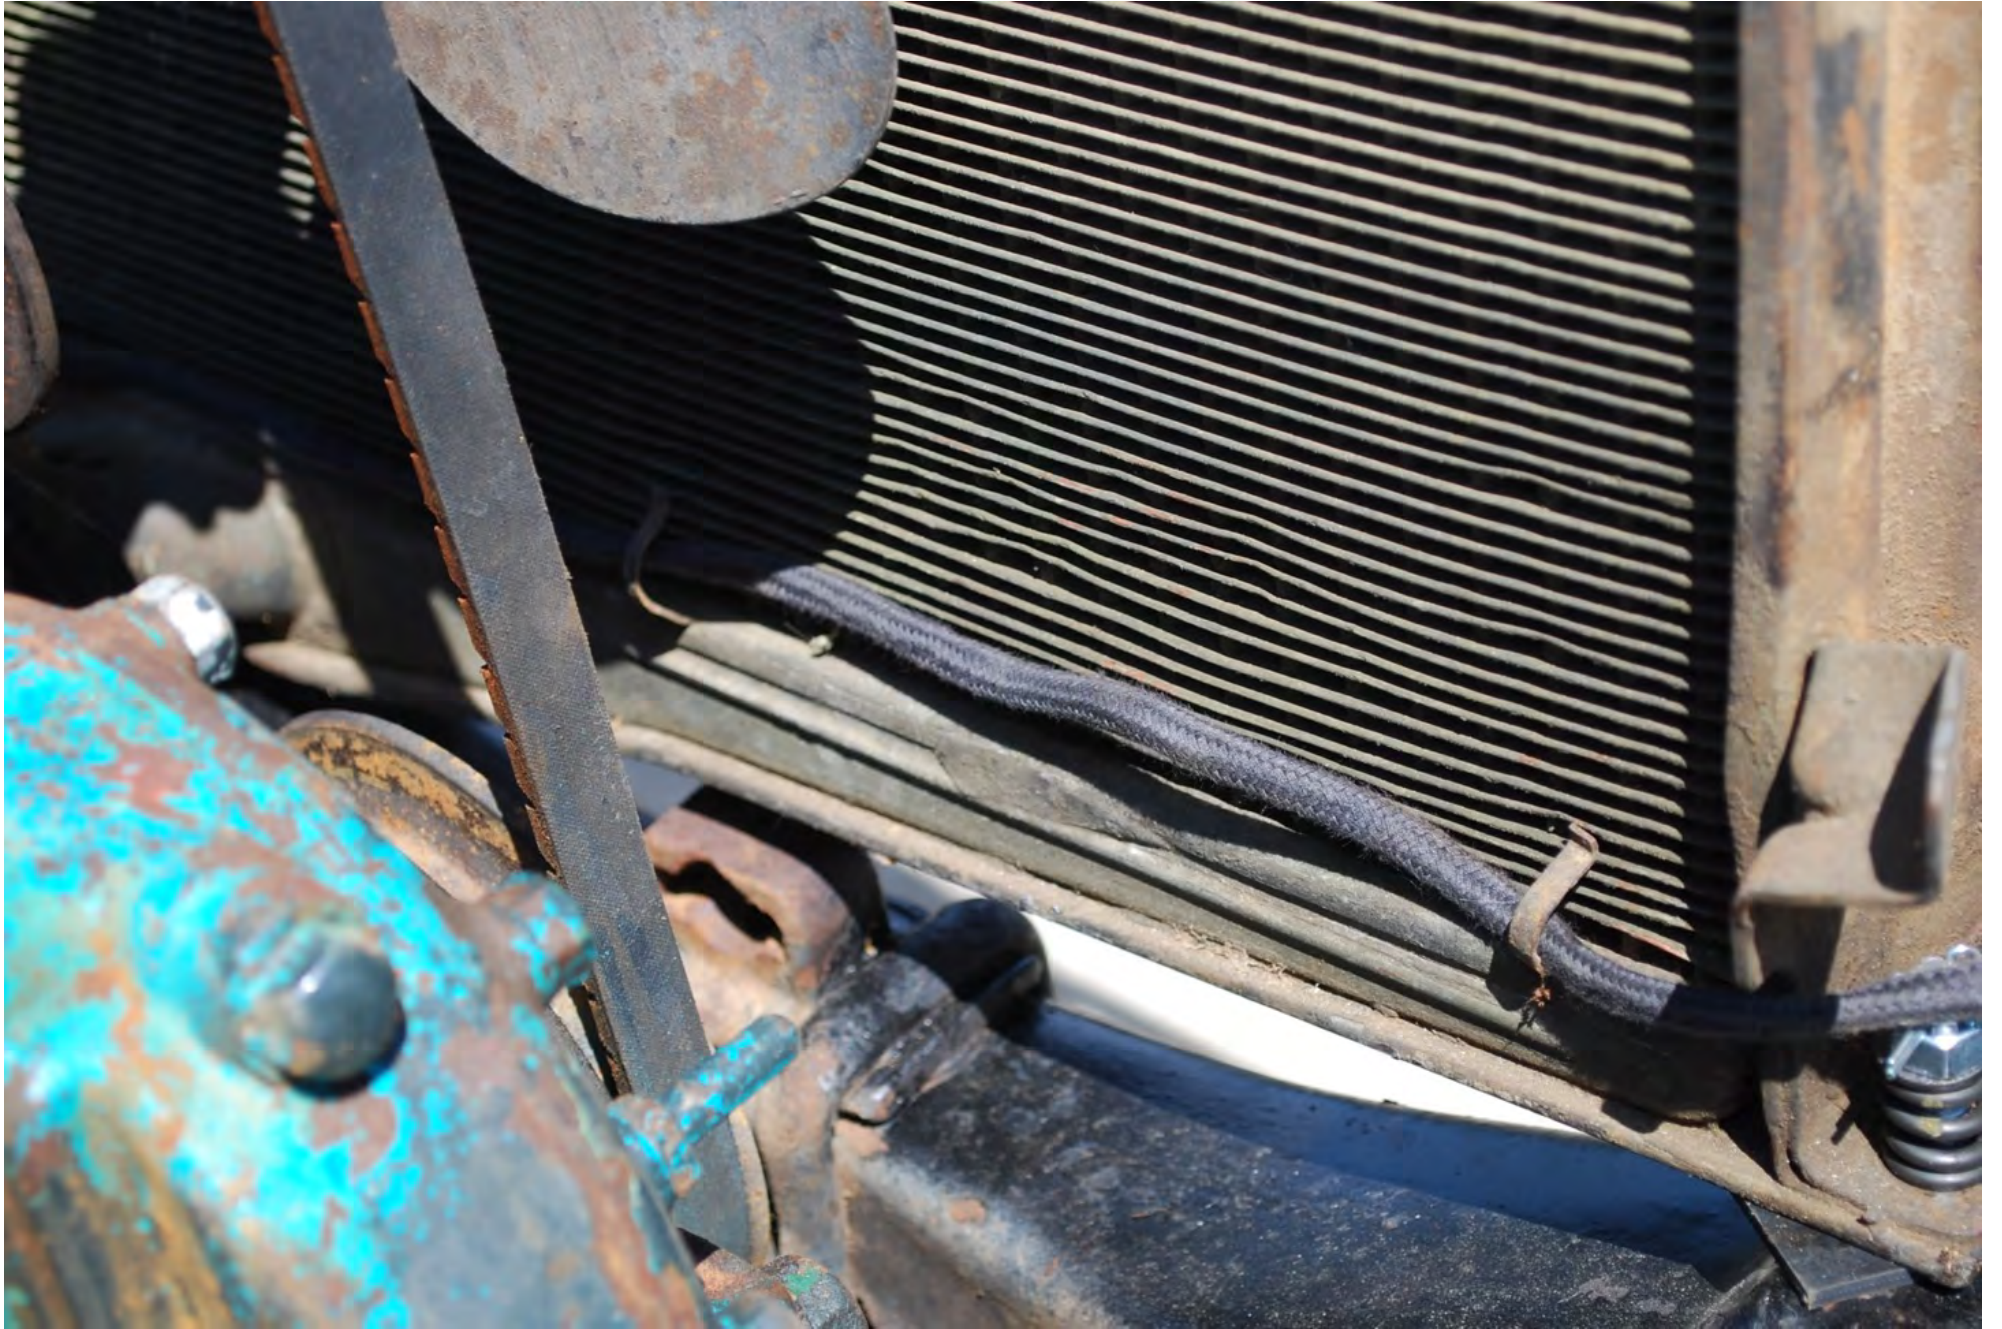
Fig. 929

Service Bulletin – June 1930

KEEP HEADLAMP WIRE LOOM
AWAY FROM BRACKET

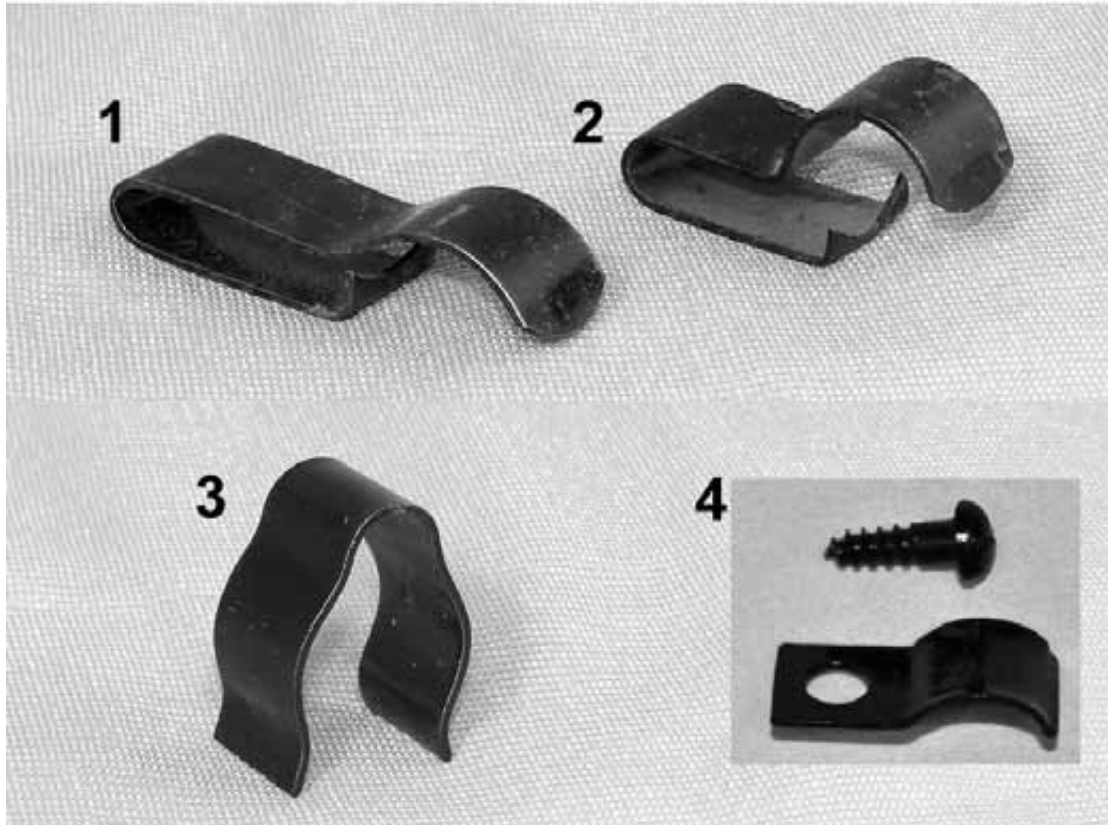
Wire Clips

1 - A-14585 Rear harness to frame clip.
5 req.

2 - A-14565 Rear harness to fender
bracket or skirt. Used with teacup
style rear lamp. 1 req.

3 - A-14595-A Rear harness to lamp
bracket. Used with drum style rear
lamp. 2 req.

4 - A14592 Rear lamp harness to body.
used on most Fordor bodies and many
commercial bodies.

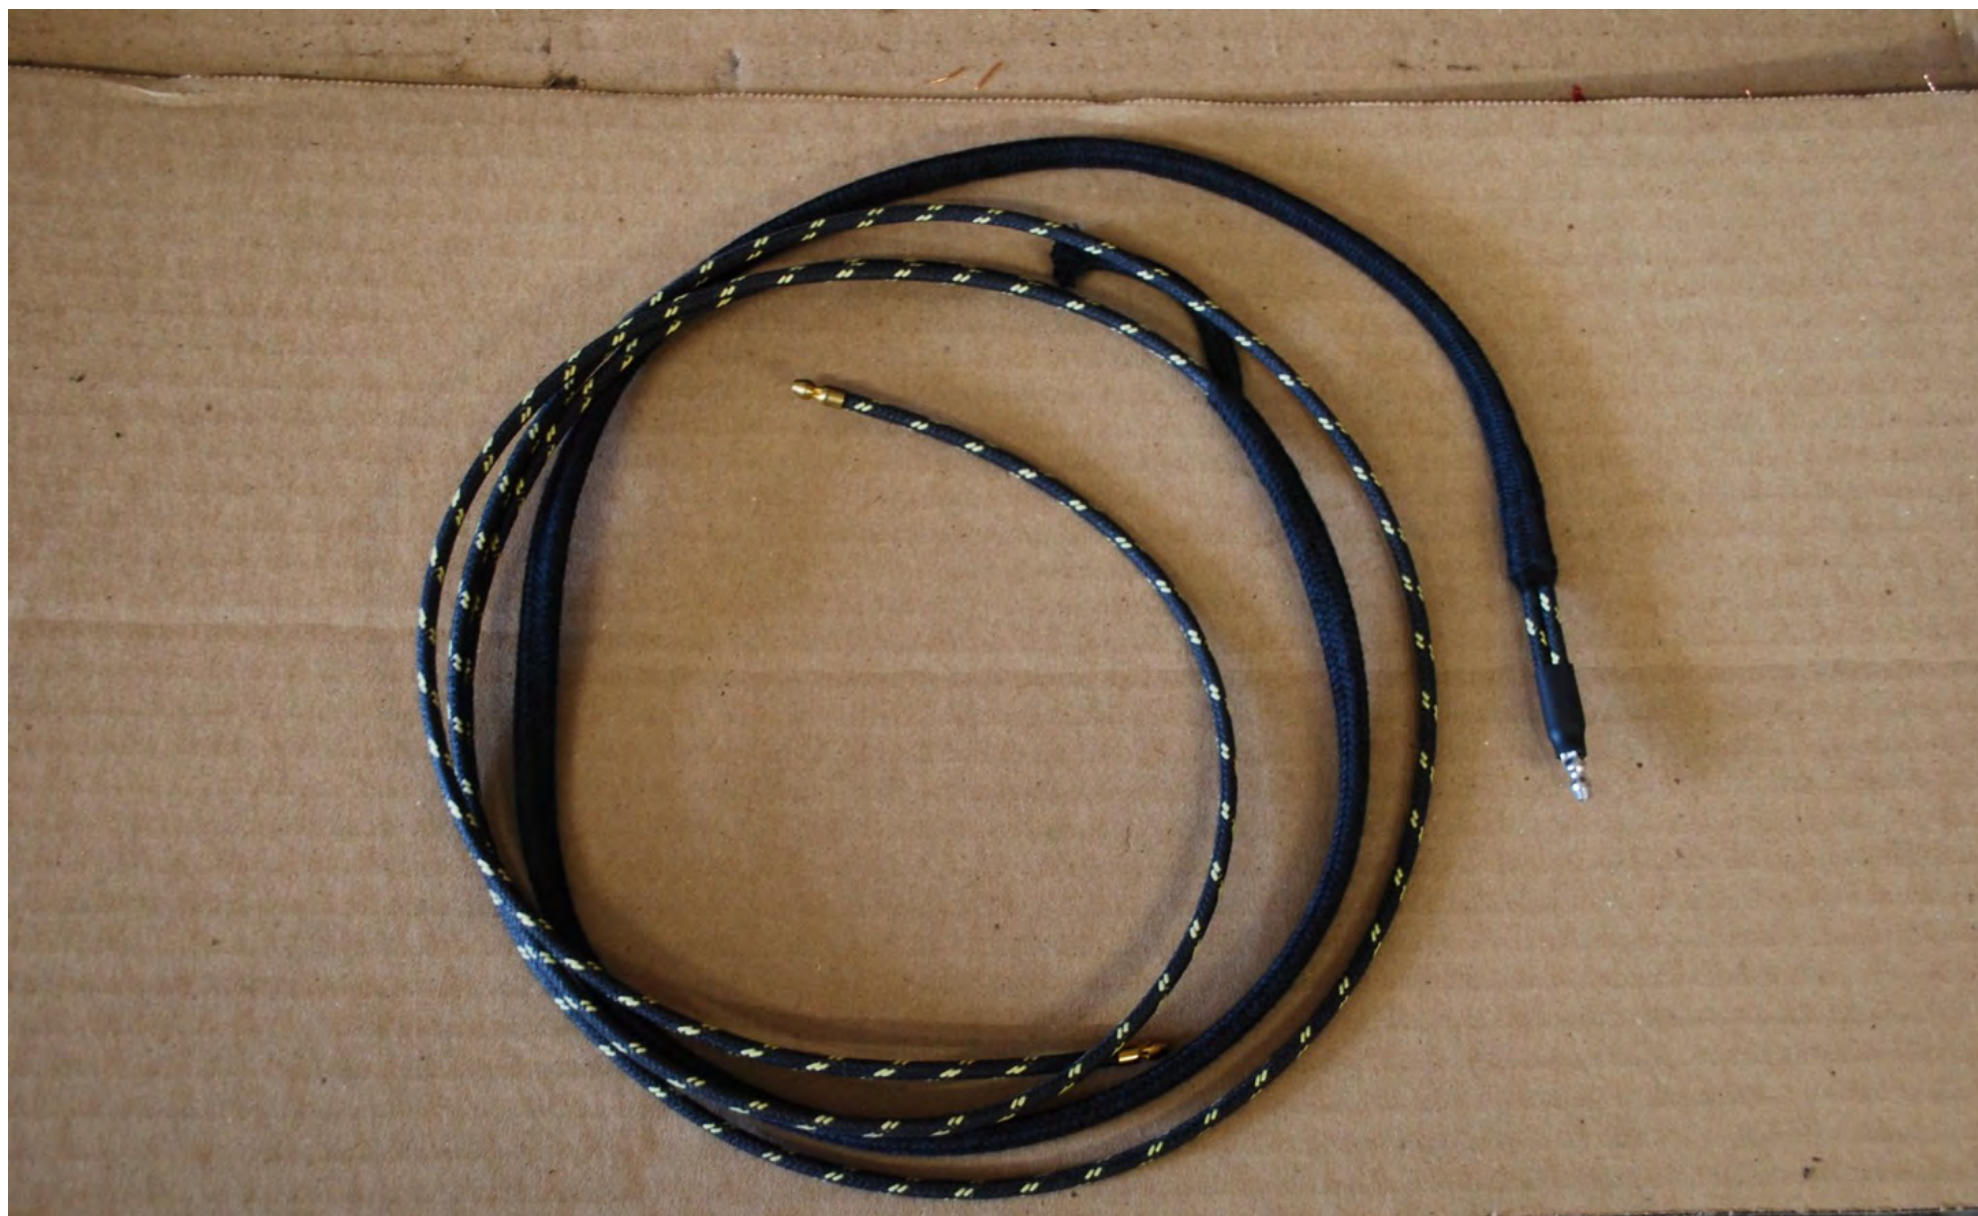
Cross Over Wire – Dual Tail lights

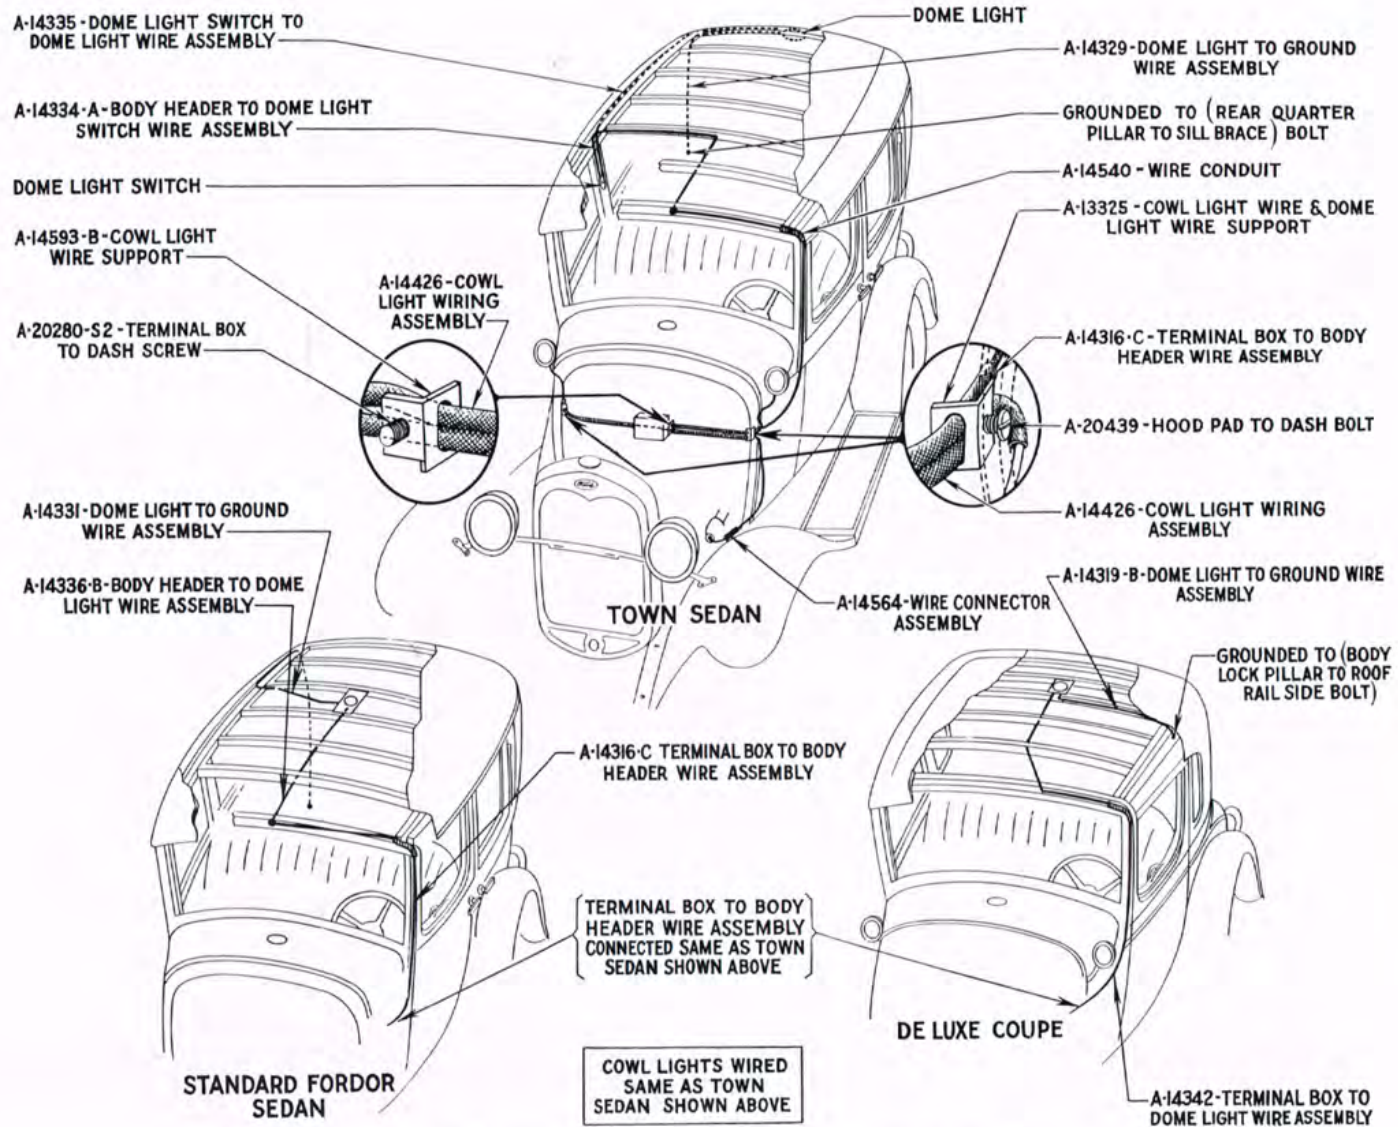
Cowl and Dome Lights

Service Bulletin
June 1930

Fig. 938—Wiring Diagram of Town Sedan, Standard Fordor Sedan and DeLuxe Coupe

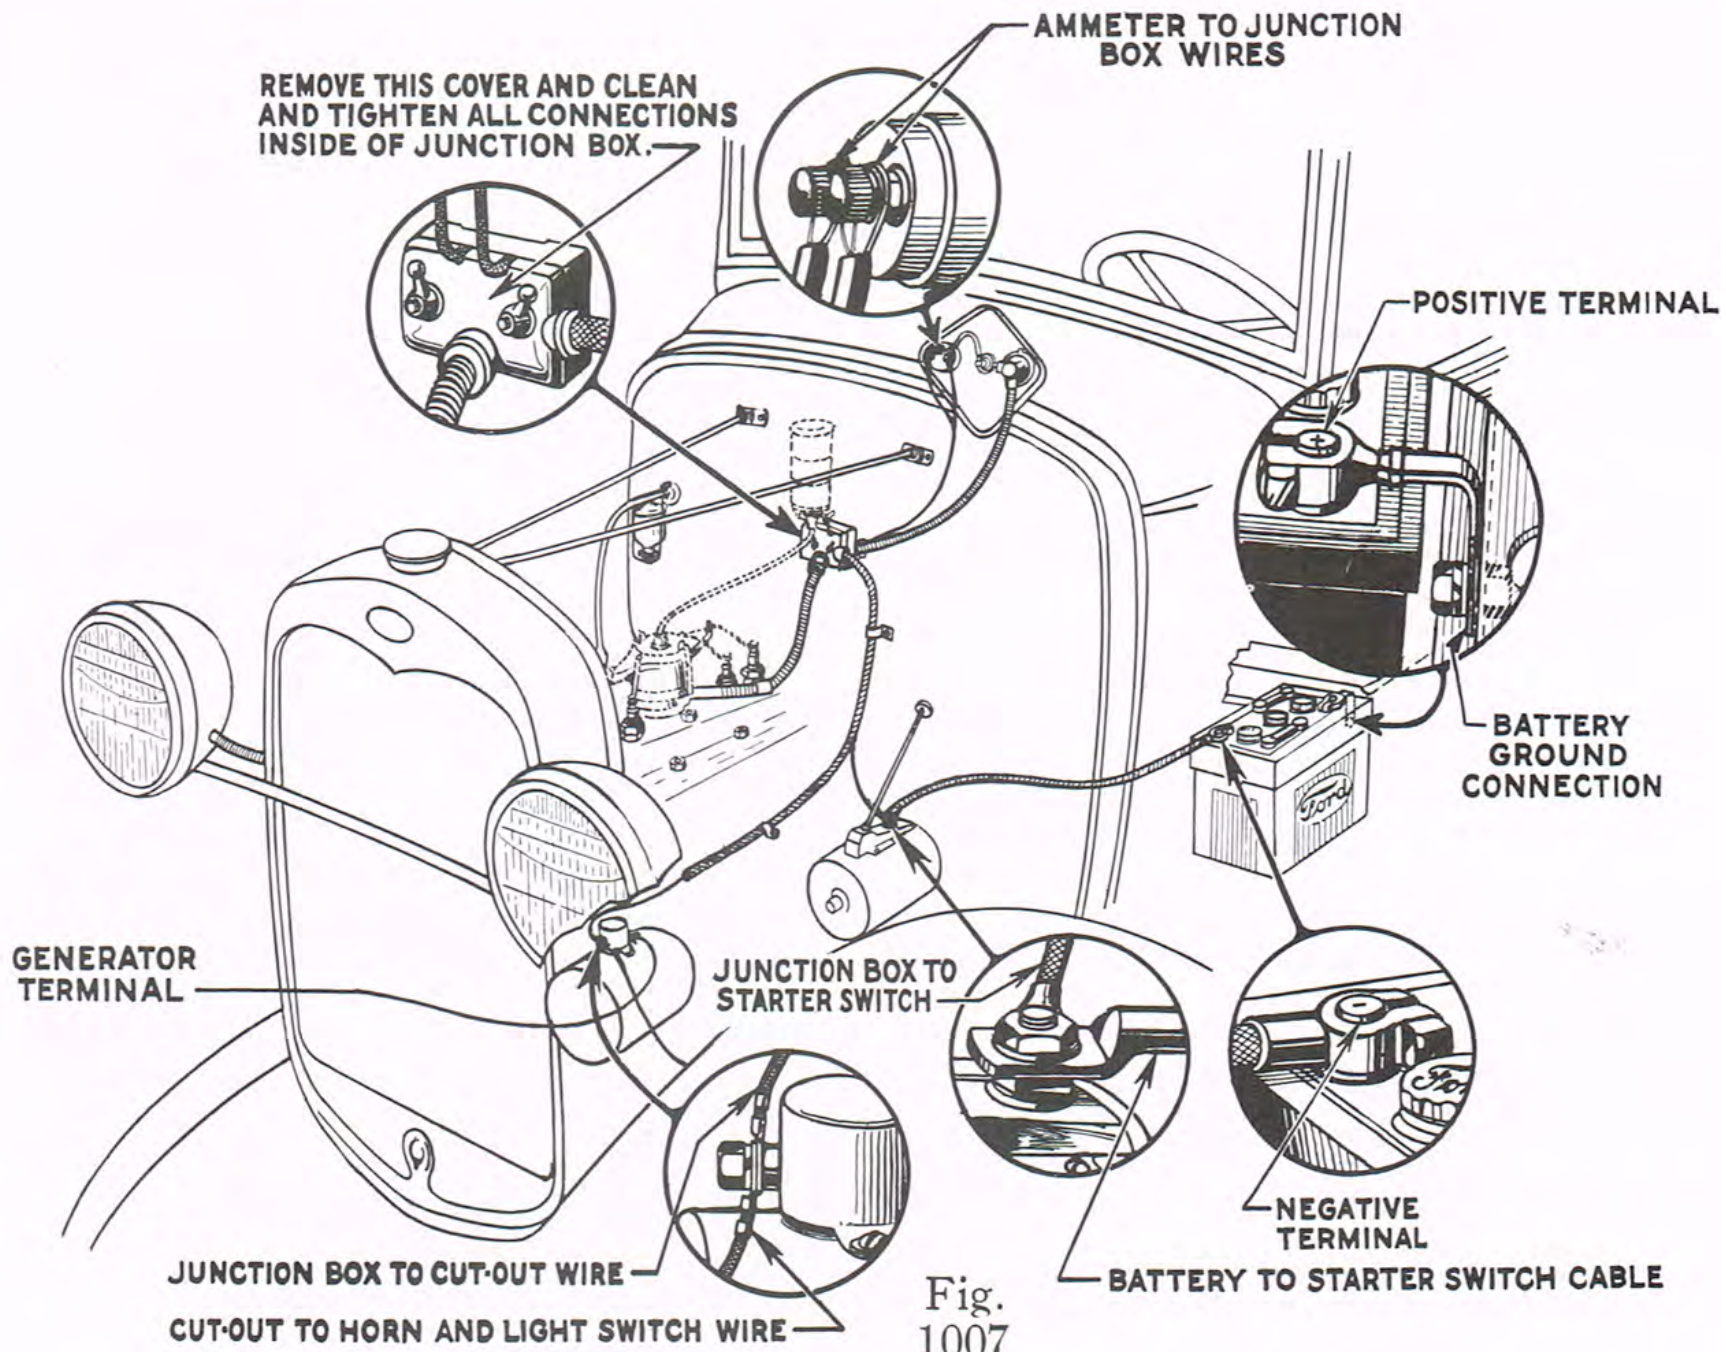
These connections must be keep clean and tight. Service Bulletin
October 1930

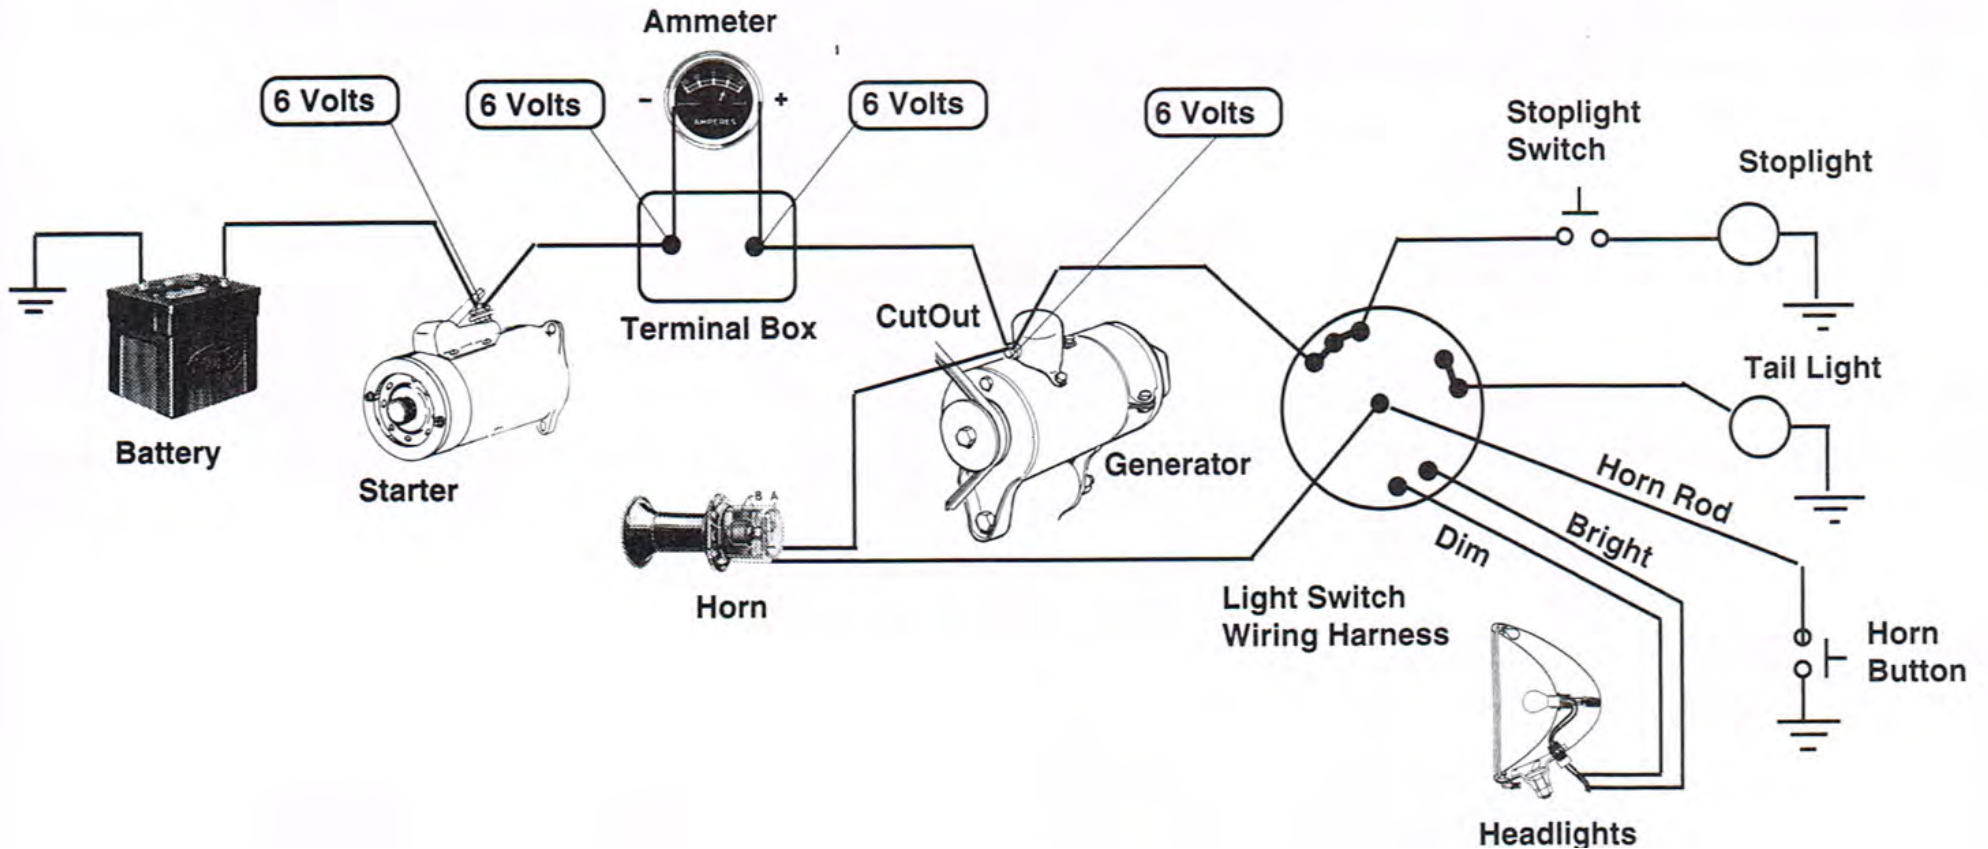
Where To Find Voltage

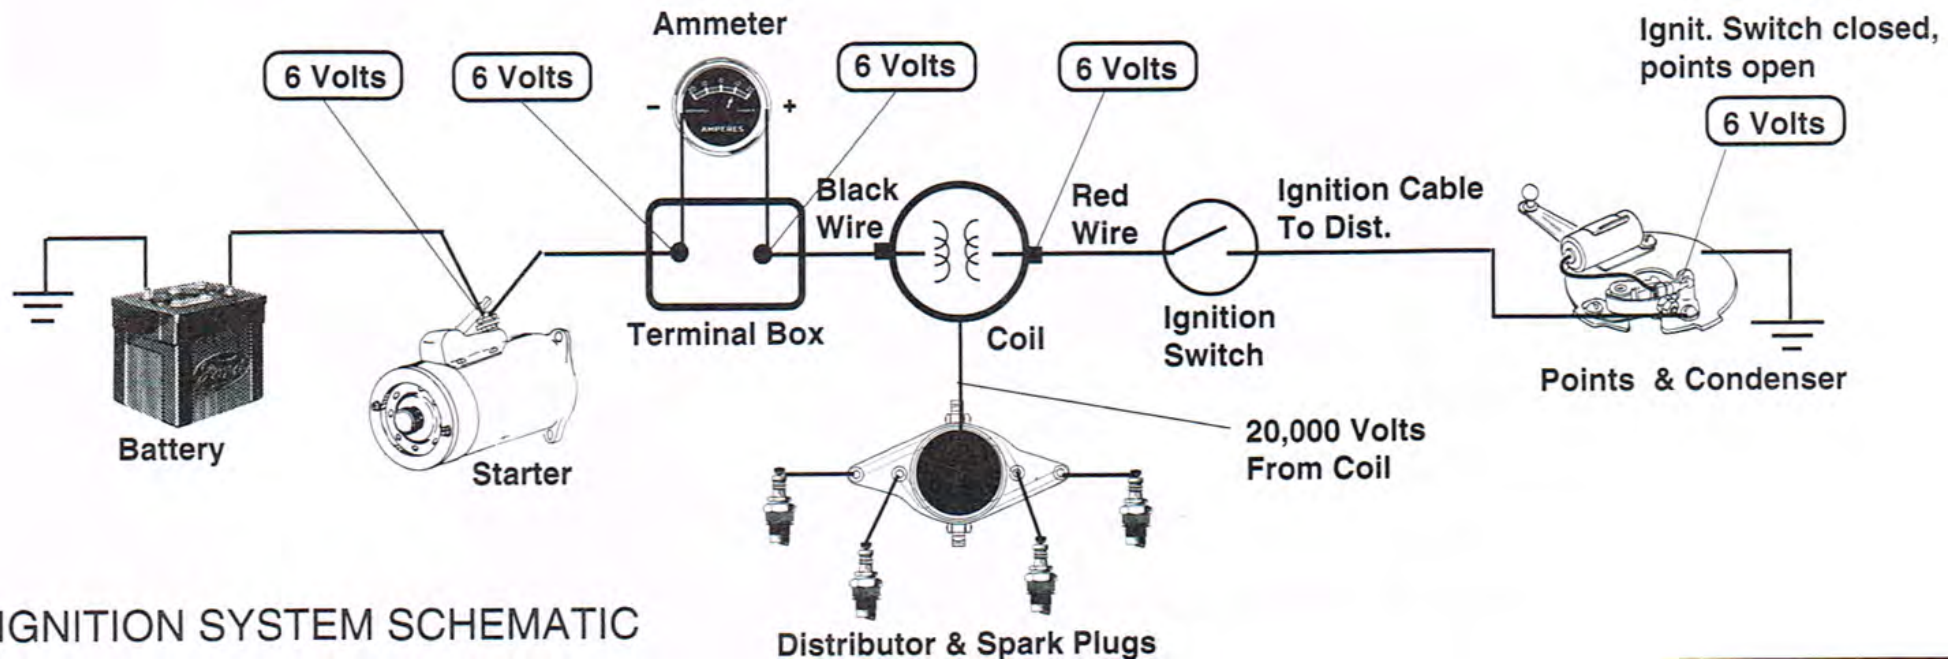
IGNITION SYSTEM SCHEMATIC

- Test for 6V at Starter
- Test for 6V at both Terminal Box Nuts
- Test for 6V at both Coil Terminals
- Open Point – Insert Piece of Paper – Then turn on Ignition (Key On) – Test for 6V on Arm

If any test failed, trace the fault to a disconnected or broken wire in the circuit
